NAVAL CIVIL ENGINEERING LABORATORY
Port Hueneme, California

FERRO CEMENT PANELS
VOLUME I

Experimental Evaluation
and Protective Potential

Report No. CR 69.008

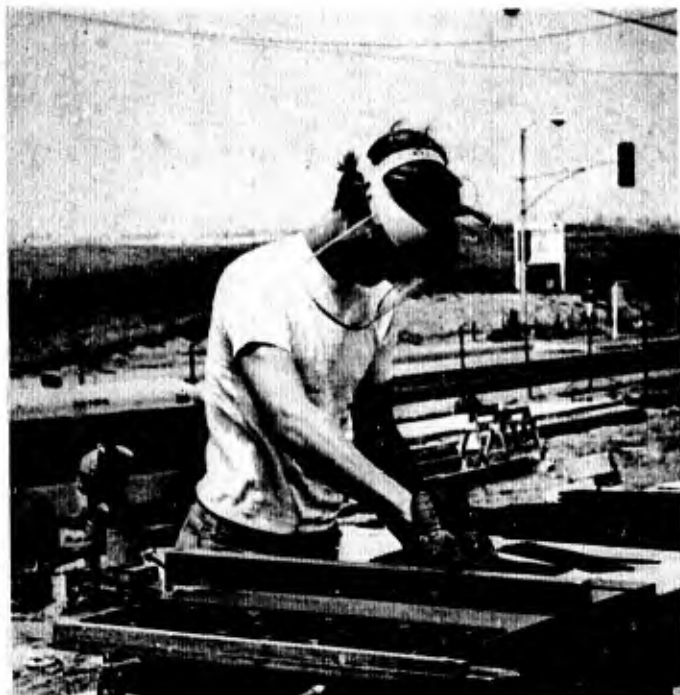
For the $27\frac{1}{2}$ "x $27\frac{1}{2}$ " panels, the $27\frac{1}{2}$ "x $97\frac{1}{2}$ " sheets were cut to 4 - $27\frac{1}{2}$ "x $24\frac{1}{4}$ " pieces which were stacked, 9 to a panel with the long directions alternated at 90 degrees. A photograph of the reinforcement cutting operation is shown in Figure 2-1. All reinforcement stacks were securely wire tied.

Figure 2-1
Cutting of Reinforcement

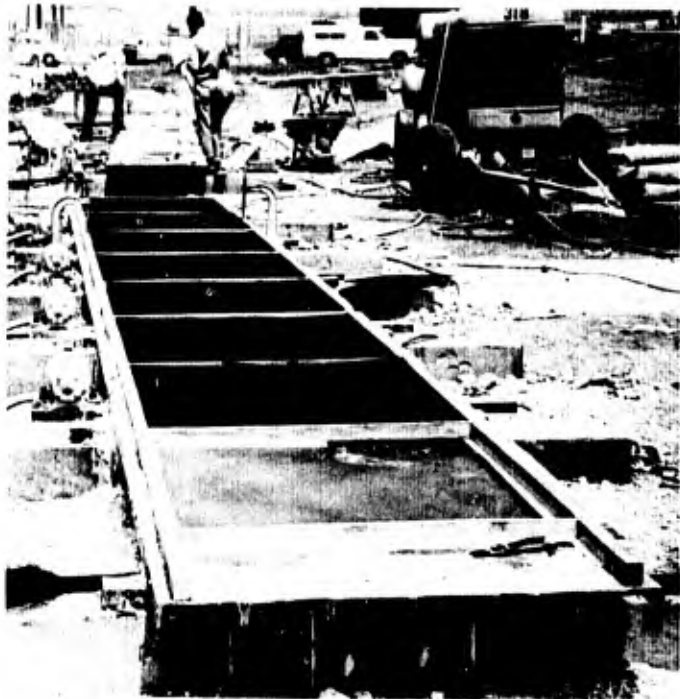
The vibrating table used in the parametric tests would not accommodate the $41\frac{1}{2}'' \times 41\frac{1}{2}'' \times 2''$ panel forms, consequently form beds had to be fabricated. It was decided that multi-panel beds would be used. The beds each formed 8 - $41\frac{1}{2}'' \times 41\frac{1}{2}''$ panels or 12 - $27\frac{1}{2}'' \times 27\frac{1}{2}''$ panels. These beds are shown in Figures 2-2 and 2-3. Four turbo-vibrators were affixed to the form bed in use (Fig. 2-4).

Figure 2-2 Multi-Panel Form Bed,
41½"x41½"x2" Panel Forms

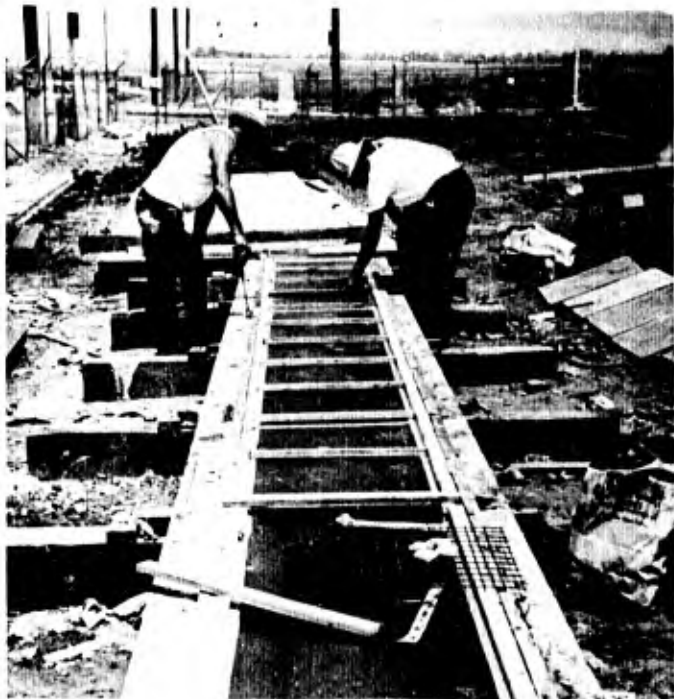
Figure 2-3 Multi-Panel Form Bed,
27½"x27½"x1" Panel Forms

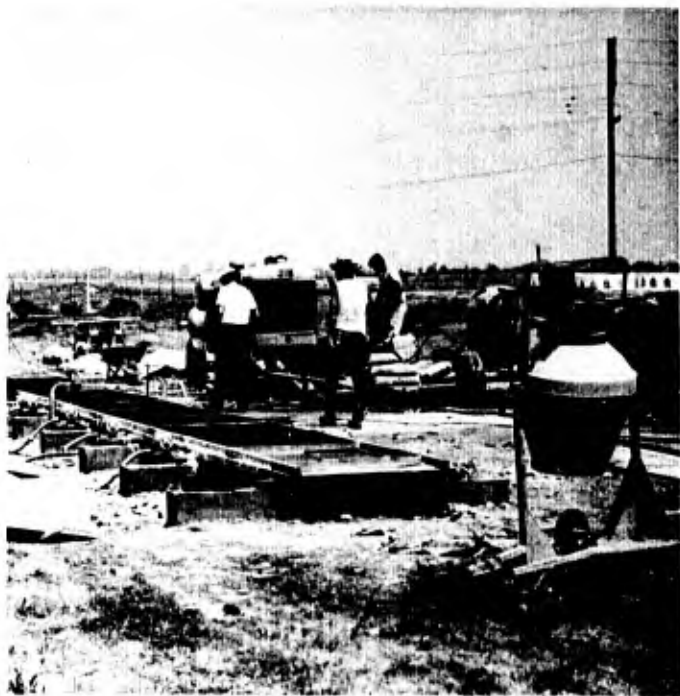
Figure 2-4 Turbo-Vibrators
Attached to Form Bed

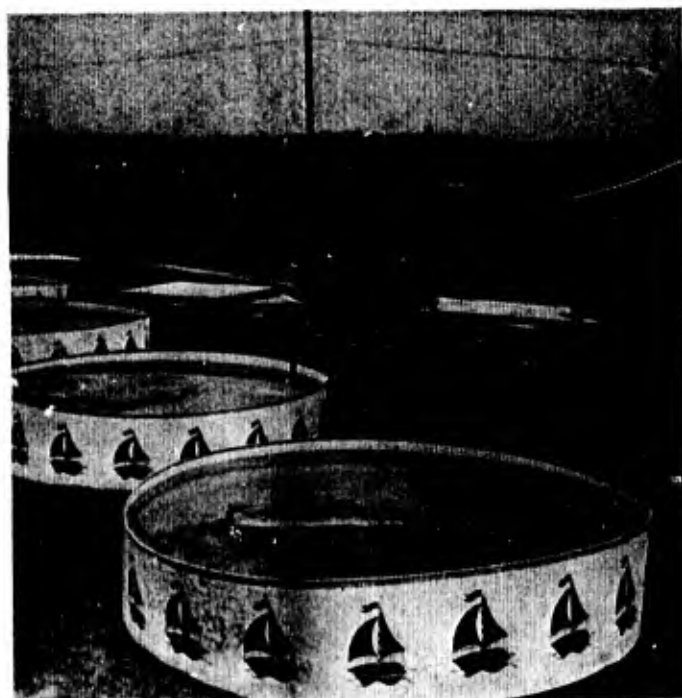
After finishing, the panels were covered and exposed overnight to a warm, vapor saturated atmosphere. On the following morning the covers were removed and the panels allowed to harden and gain enough strength to be stripped. They were then submerged in a saturated lime solution for a period of 3 to 4 days. Ordinary playground plastic wading pools were used for tanks (Fig. 2-6).

Figure 2-6 Panels Curing in Saturated Lime Solution

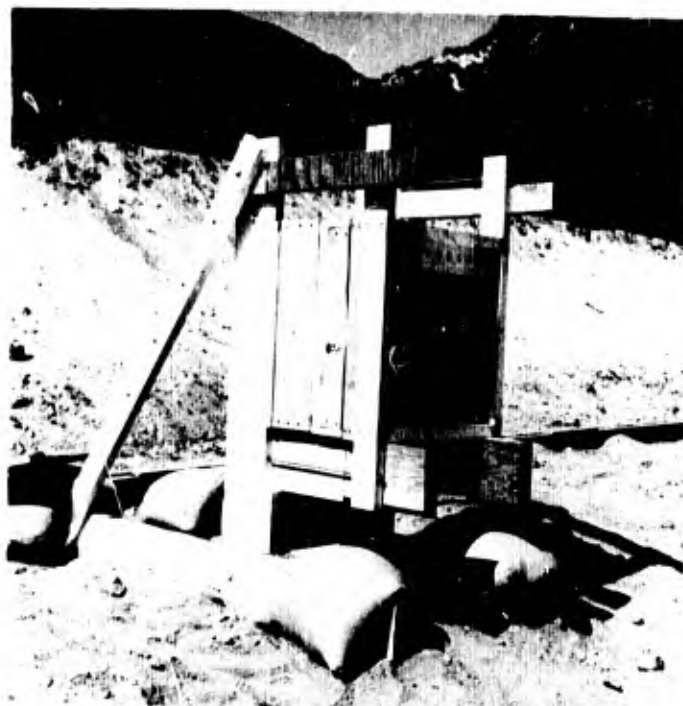
- b. The panel supports (Figure 3-1) were fabricated by a finish carpenter of straight grained Douglas Fir. Spacers used between multiple panels in tandem were in picture frame configuration, with rabbeted joints at the corners. Retaining frames with rabbeted corner joints were drawn against the front of the panel and spacer assembly by torquing the nuts on threaded rods through the frames and the main body of the supports. All four-edge contact surfaces were brought as near to a plane as finish carpentry tools would produce. The rear braces of the supports were bored for adjustment of the panels at angles with the horizontal of 90 degrees, 75 degrees, 60 degrees, 45 degrees and 30 degrees. (Figure 3-2) The supports were spirit-leveled fore and aft and sideward and each of the two skids was sand-bagged at its extremities. (Near the end of the experiments, a $\frac{1}{2}$ " panel, precariously balanced on its lower edge with no other support, was exposed to two rounds of cal. .30-06 fire and one of cal. .280, near its upper edge without disturbing its balance.)

Figure 3-1 Panel Support and Spacers,
Parametric Experiments

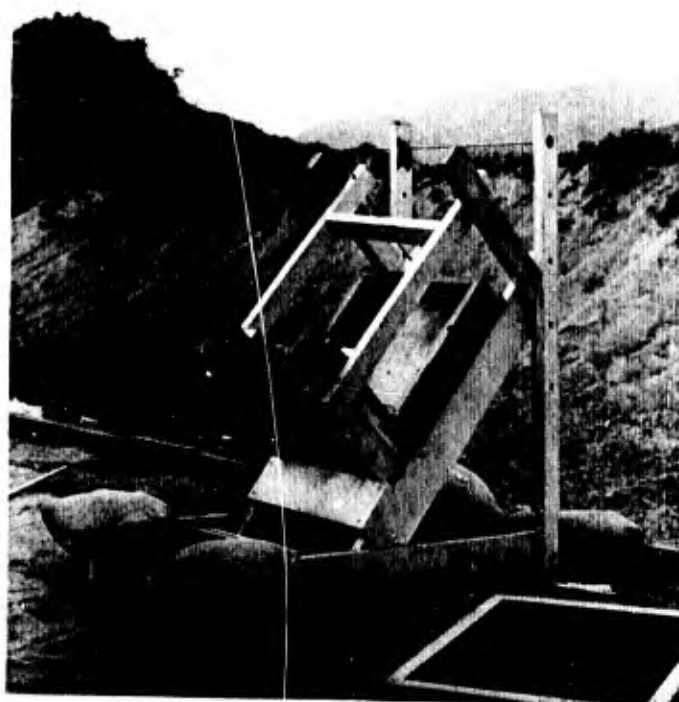
Figure 3-2 Panel Support at
Oblique Angle of Incidence

Two panels of Fast Fix I cement were tried in Experiment 7. In Experiment 8, the incident angle of the line of sight was varied. The angle between the line of sight and the tangent to the trajectory of a caliber .30-06 bullet at 100 yards is about 5 seconds. The supporting frames, which were spirit-leveled, could be adjusted to 90°, 75°, 60°, 45° and 30° and, by expedient means, at 52½°. The line of sight was found by transit measurement to ascend 3° from the bench rest to the panel. In set-up No. 3, the support was reversed in order to ground the expected ricochet, which did not occur. The support was then restored to its original orientation.

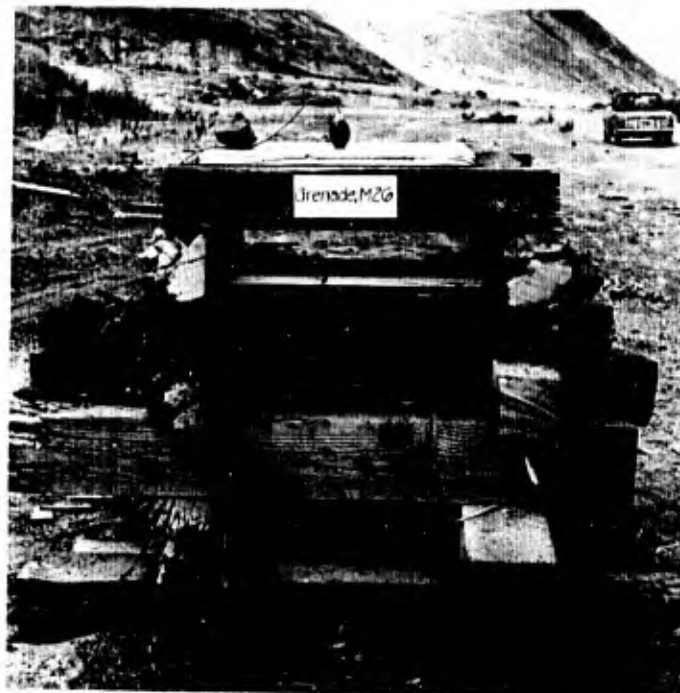
- a. It was anticipated that any support used in these experiments would be severely damaged. Cribbing was chosen because a partially disarrayed crib may be quickly restored and destroyed cribbing may be replaced without carpentry. (Figures 3-3 and 3-4). Eight-by-eight cribbing was used from the ground to the lower panel and six-by-six's were used where necessary to space the panels at the desired distance. Rigidity and four-edge support were provided by the use of wedges and wedge shingles. Figure 3-5 shows the use of fill cribs and wedges to complete the four-edge support. The TNT charge was placed in the center of the top panel. (Figure 3-6).

Figure 3-4 Crib Panel Support,
Surface Blast Experiments

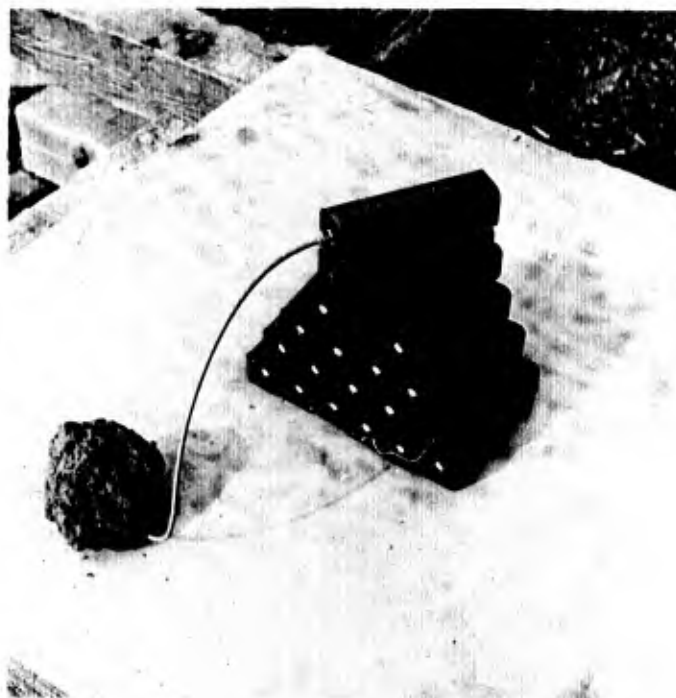
Figure 3-6 Placement of
Surface Blast Charge

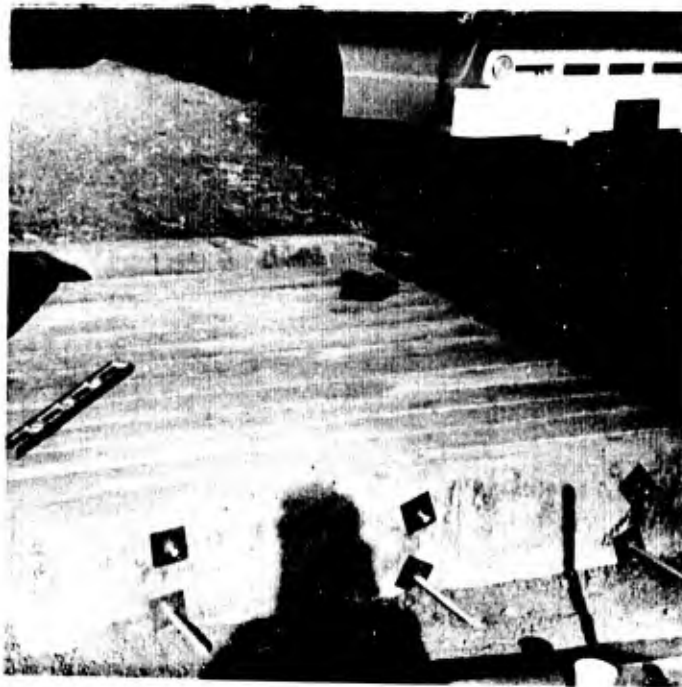
- b. Since it was anticipated that panels in the path of blast charges would be destroyed, but would provide protection of piers by enforcing stand off, it was necessary to provide simulation of a bridge pier. A composite concrete slab, 6'x6'x1', was placed on the ground and the crib was erected around it. (Figure 3-7). The slab was composed of 13 segments, each 6'x1'x5½", snugly interfaced by the drawing up of nuts on six 1" diameter threaded rods which ran through the assembly. Each segment was reinforced with two 3/8" diameter bars. The ground surface was prepared with hand tools. The soil was dessicated adobe so it is unlikely that uniform bedding of the slab was achieved.

Figure 3-7 Composite Slab,
Pier Simulator

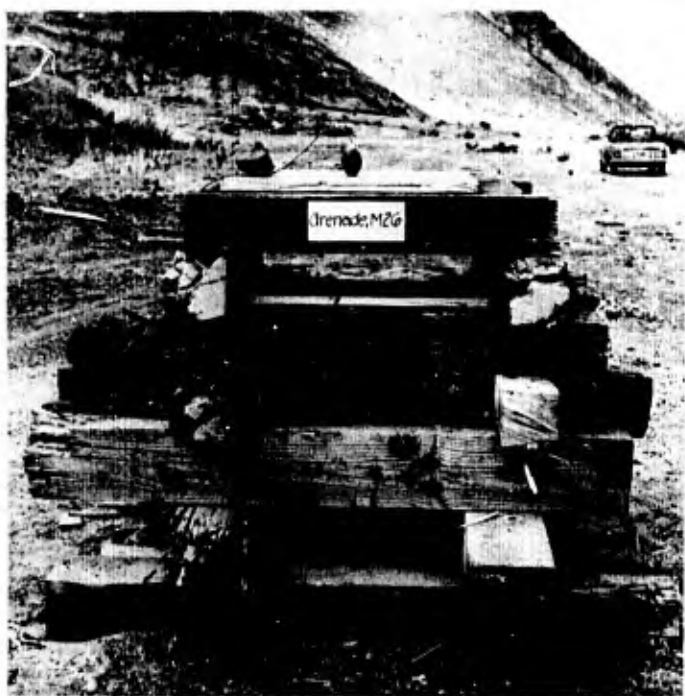
Figure 3-11

The hand grenade, M26, was placed on the top panel with its axis of symmetry vertical, fuze well up, as shown in Figure 3-11.

Placement of Grenade,
Hand, M26

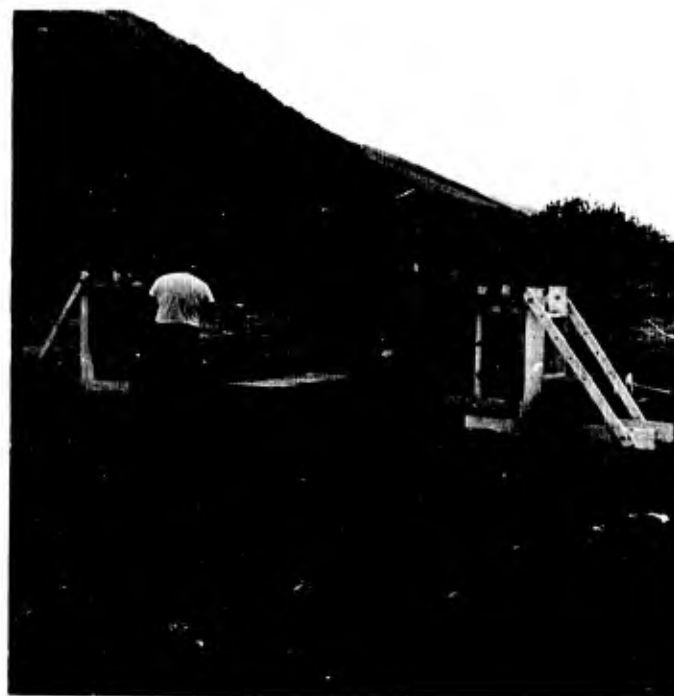
Figure 3-12

In these experiments, with the shells placed vertically, three stand offs were tried with each detonation. Three panels in tandem, placed vertically at $6\frac{1}{2}$ " spacing, were supported at two stand off positions in supports which were used in the parametric experiments and, at the third stand off, in supports composed of two sills, laid across two pieces of cribbing, with pairs of 2x4's, edge interfaced, nailed in vertical position to the sills. The panels rested on the sills and occupied spaces between pairs of 2x4's, thus being spaced at 7". The assembly was securely braced, fore and aft and sideward and the 2x4 verticals were drawn snug against the panels by means of wedges. Supports were set at three stand off positions around the pier simulator which had been used in the blast experiments and blocking was placed on the simulator to support the shell, base down, at panel height. The third stand off position provided only 2-edge support. Views of the three position arrangement are shown in Figures 3-12 and 3-13 and views of the placement of shells in Figures 3-14 and 3-15.

Three Stand Off Position Arrangement,
Fragmentation Experiments

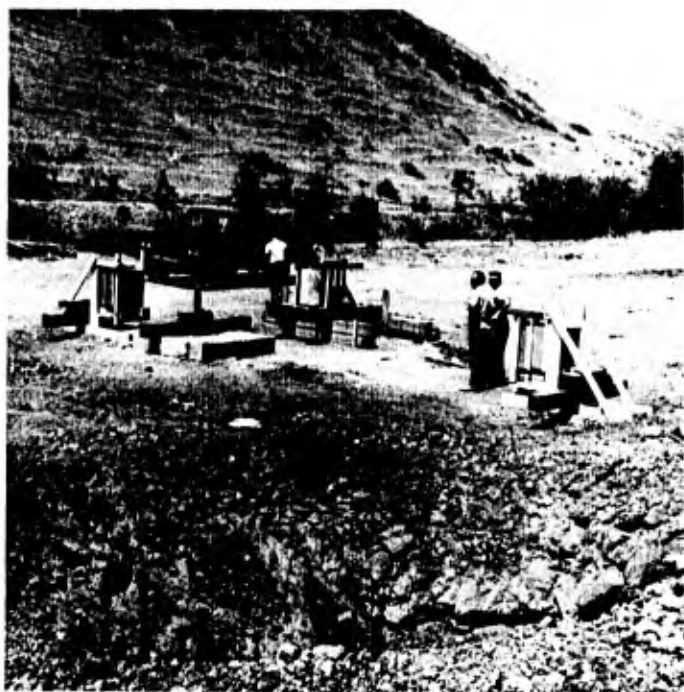
Figure 3-13

Three Stand Off Position
Arrangement, Fragmentation Experiments

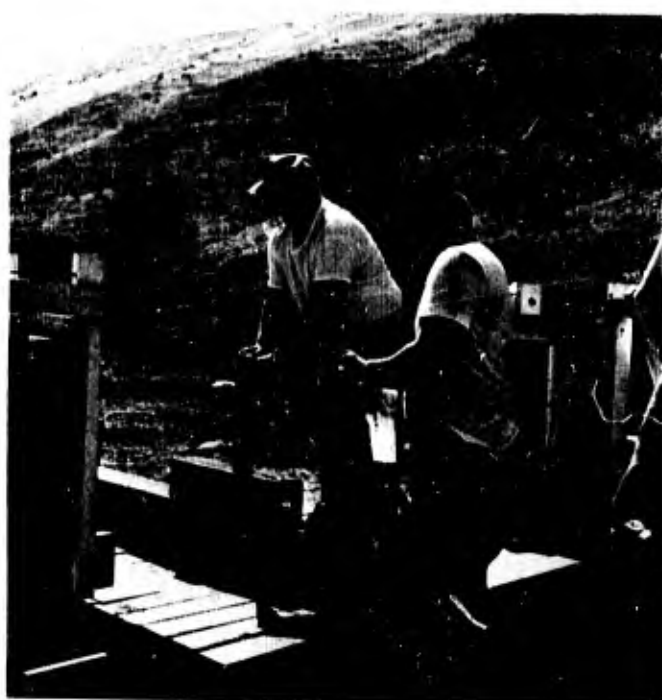
Figure 3-14

Placement of Shell,
Fragmentation Experiments

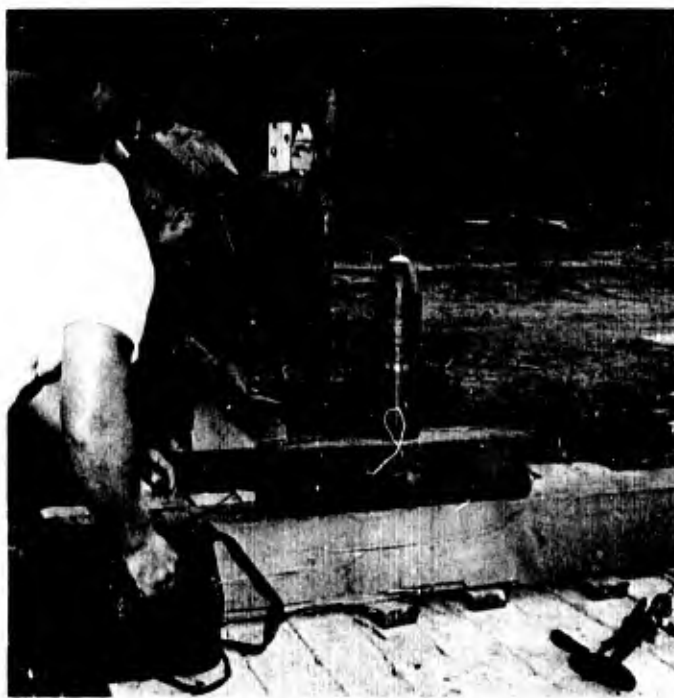
Figure 3-15

Placement of Shell,
Fragmentation Experiments

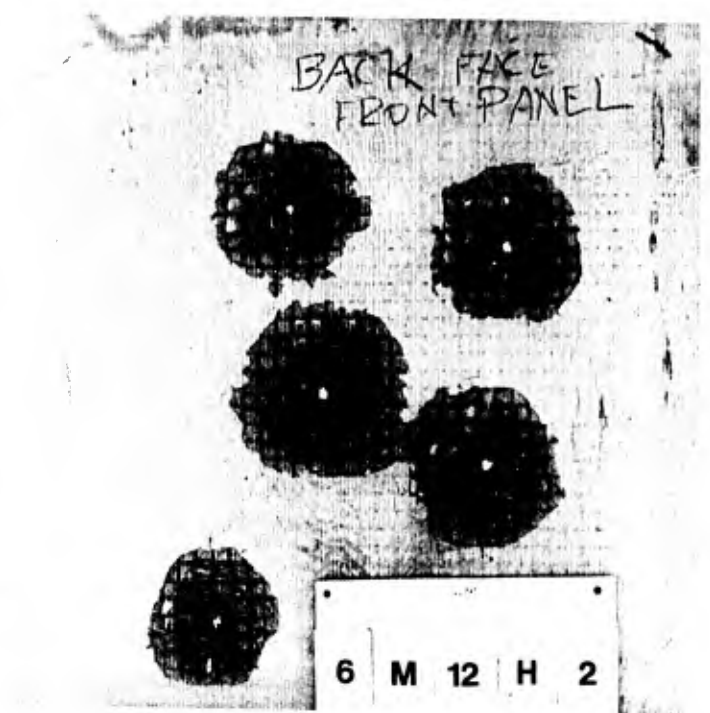
Figure 4-2.206 Back Face, 1½" Panel reveals the wire severance and spalling on the back face after five rounds were fired.

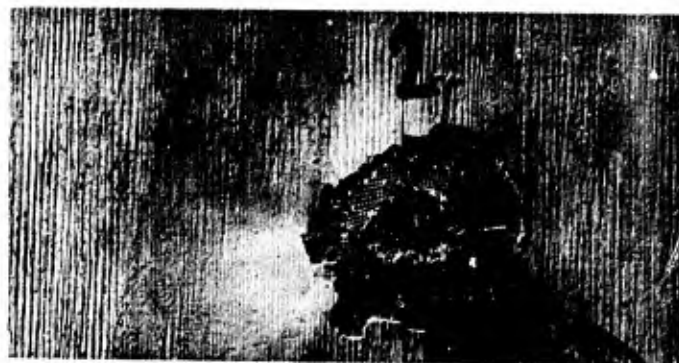
Figure 4-2.306 Back Face, Panel No. 41
as Front Panel

Figures 4-2.301 and 4-2.305 reveal the effect of the fiber glass screen on front face spalling in the front panel; Figures 4-2.302 and 4-2.306 reveal the effect on back face spalling.

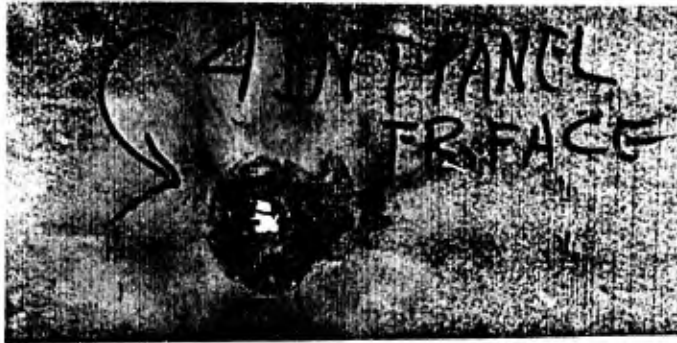
Figure 4-2.313 Front Face, Panel No.41 as
Intermediate Panel, 3½" Back
of Panel No.42

When either Panel No.41 or Panel No.42 were backed up by a 1" Panel, reinforced with ½" mesh wire cloth, at a clear distance of 1-7/8" both panels were penetrated. When Panel No.41 was backed up by Panel No.42 at 3½" clear distance, the bullet lodged in Panel No.42, bulged the mesh on the rear face and caused extensive rear face spalling. No damage was done to the back up panel, 3½" back of Panel No.42. When Panel No.42 was backed up by Panel No.41 at a clear distance of 3½", both panels were penetrated. A back up panel 3½" back of Panel No.41 was undamaged. The mutilated copper jacket of the bullet was found lying on the lower member of the spacer. In both arrangements with a back up panel, the dust fines which adhered to it were darkened by the inclusion of lead dust fines from the core of the bullet. These observations and the total absence of damage to the back up panel demonstrate that the bullet was destroyed in the process of penetrating two panels. The performance of a bullet with a hard steel core is not known. The Cal. .30-06 bullet has a lead core. Parametric selection is primarily for shell fragments, which are hard. Fragments will lose more energy during penetration than would hard bullets, however, because their shape is irregular.

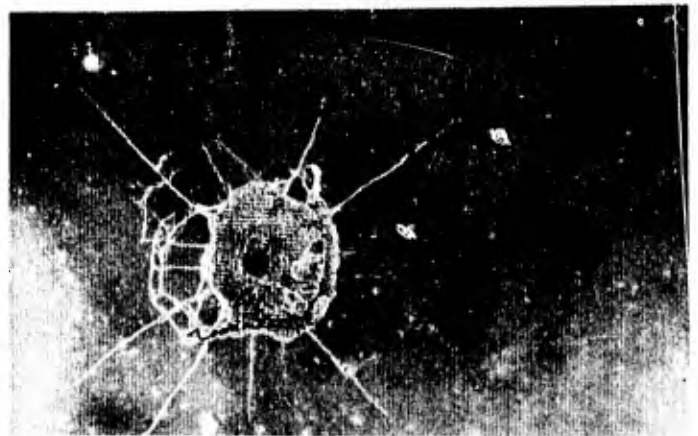
Figure 4-2.321 Second Round, Front Face, Panel No. 43 as Front Panel

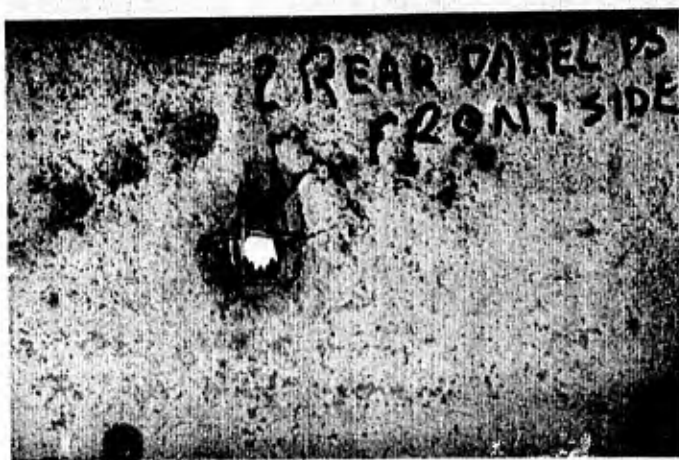
Figure 4-2.342 Round 2, Back Face, Back Up Panel

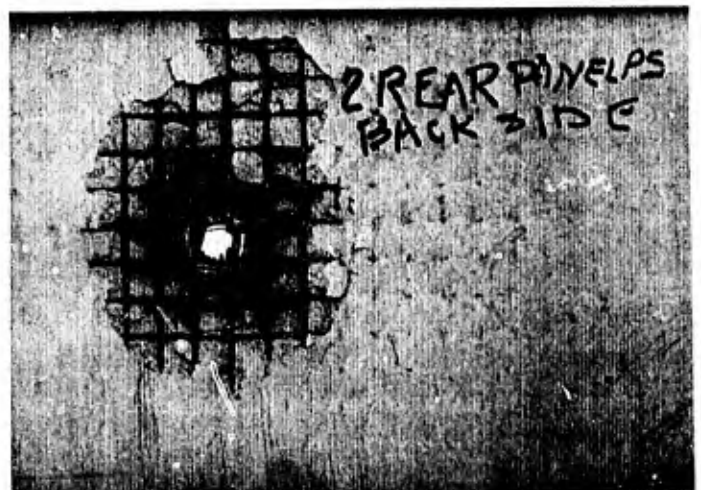
Figure 4-2.343 Round 2, Back Face, Back Up Panel

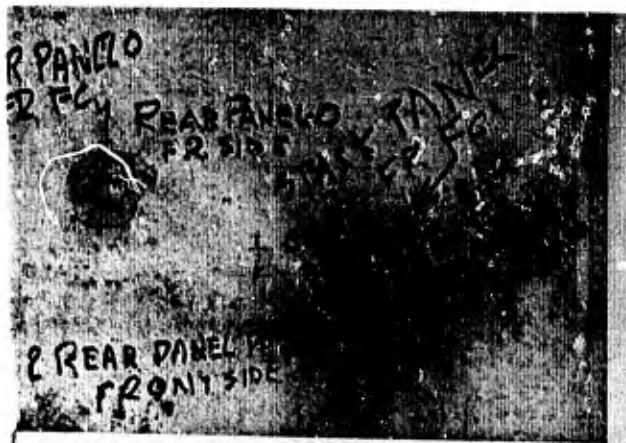
Figure 4-2.348 Front Face, Back Up Panel (Marked No. 3)

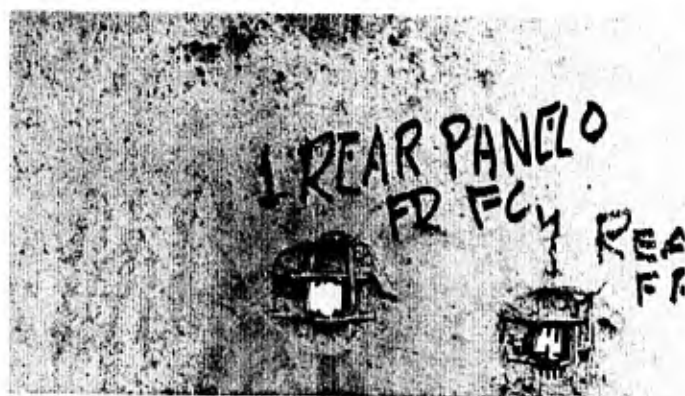
Figure 4-2.354 Front Face, Back Up Panel

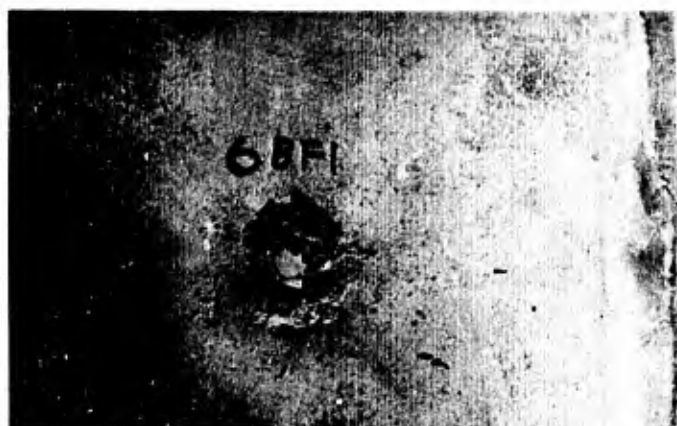
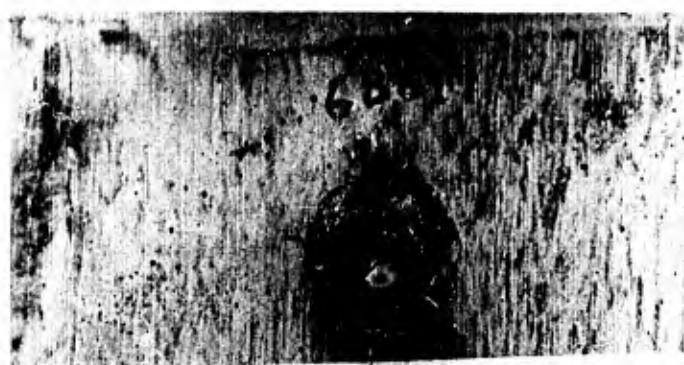
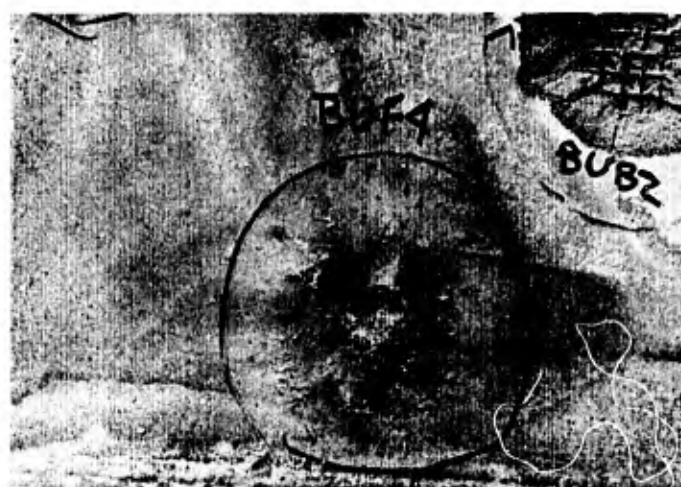
Figure 4-2.414 Round 2, Front Face of Back Up Panel (Marked BUF2)

Back face spalling of the back up panels occurred with all rounds fired and the first layer of wire mesh was barely exposed on the front face at the point of impact of Rounds 2 and 3.

The back face spalling of the back up panel is indicative of more residual energy after penetration of two panels than was indicated with 90 degree orientation of reinforcement. Dust fine powdered lead in the adhesion to the front face of the back up panel is evidence that the bullet core was pulverized and the impact on the front face was that of a jet stream of pulverized cement and lead. There appeared to be more of this material adhering to the panel face than adhered in the experiments with the mesh oriented at 90 degrees. The diameters and depths of spall areas on the front and intermediate panels were compared with those without fiber glass screen in Experiment 4 and no consistent difference was found. These measurements have a random variation between rounds in one panel.

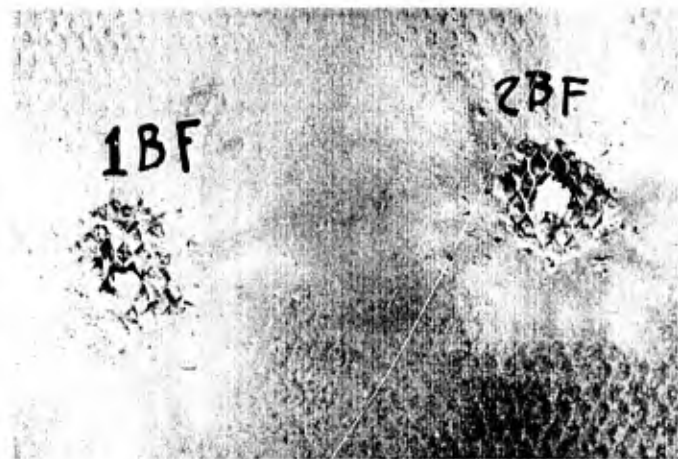
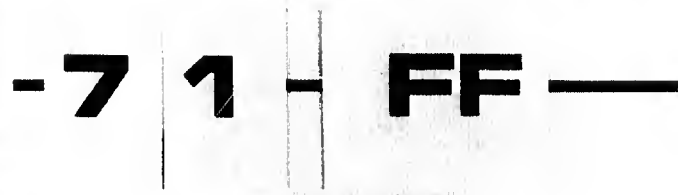
The response of the panels did not indicate any difference in the protective capability of Fast Fix I and Portland cement panels.

Both rounds made neat holes in the front panel with little front face spalling and moderate spalling on the back face. Holes in the second panel were larger and jagged and there was considerable back face spalling. The evidence of impact on the back up panel was the same as observed with two Portland cement panels in front.

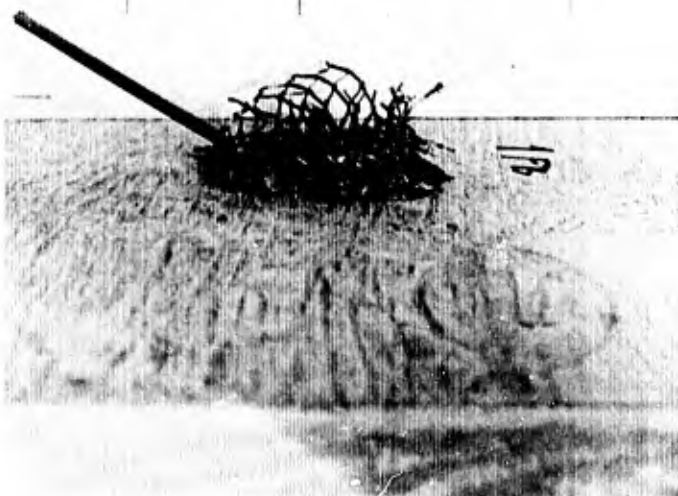
Figure 4-2.510 Path of Bullet, Rear Face

Fragments of most of the bullet were found in debris on the lower edge support

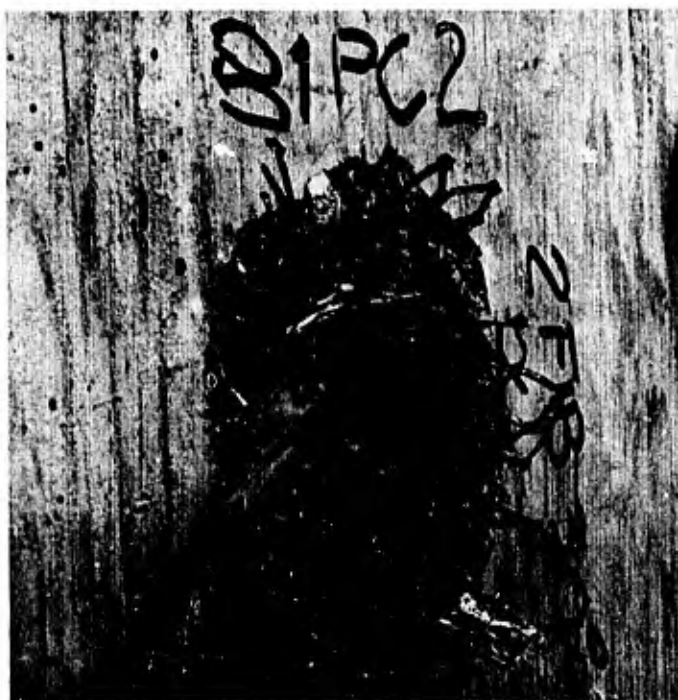
Figure 4-2.515 Back Face, Front Panel,
Line of Fire View

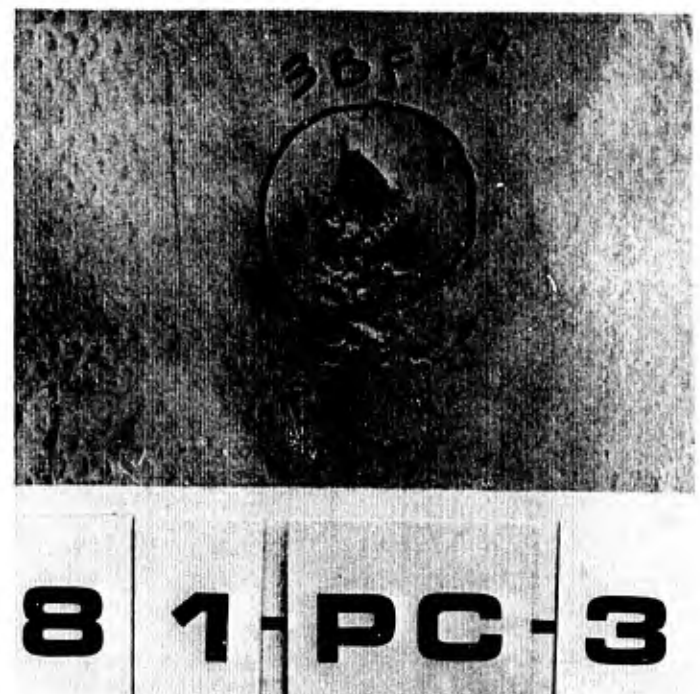
Figure 4-2.521 Slight Damage to Front
Face, Rear Panel

The back face of the rear panel showed no evidence of the impact on the front face.

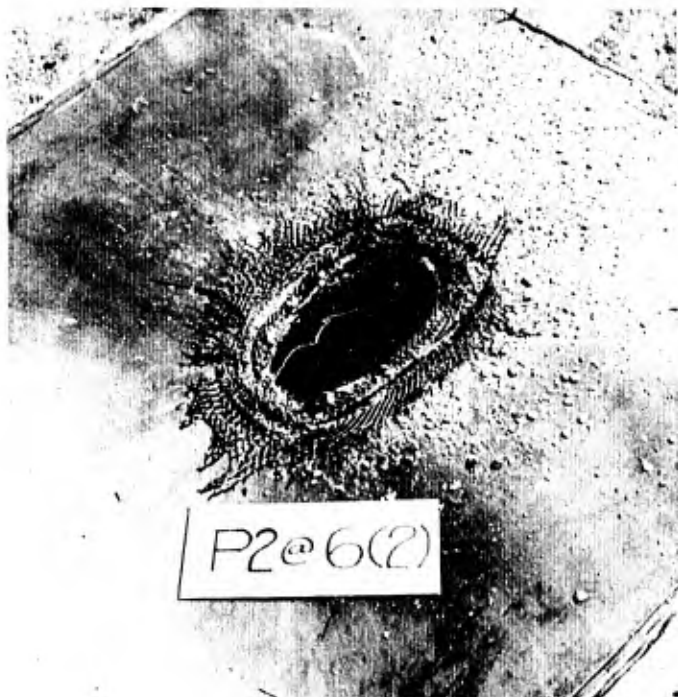
Figure 4-3.201

The hole in the top panel measured approximately 9"x6" and four layers of the top reinforcement were peeled back. The hole was about 10" in diameter at the lower surface with spalling extending out radially to a distance of about 1½" from the edge of the hole.

The upper surface of the lower panel was undamaged. Apparently the fracturing on the lower surface was terminal spall produced by the shock wave through the panel. The large flakes into which it fractured were probably due to the unintended embedment of reinforcement. A small rise at the corners of the lower panel indicated the start of flexural yield.

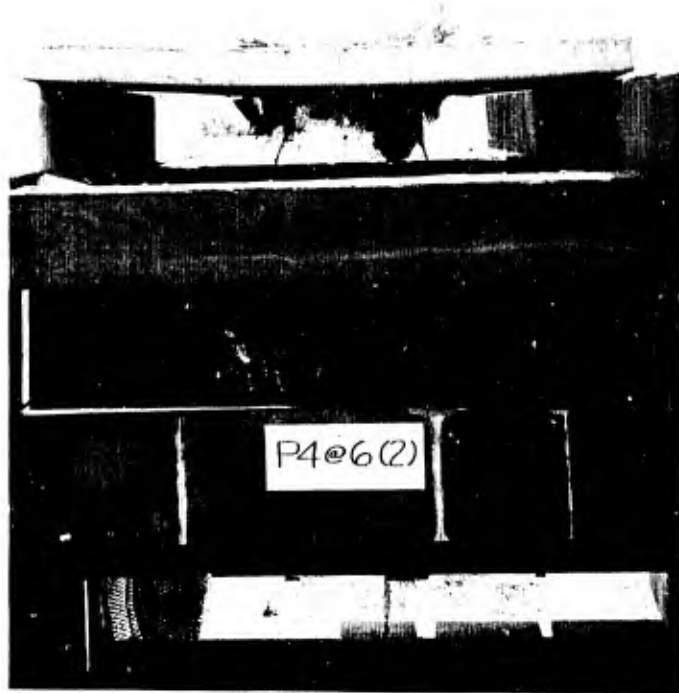
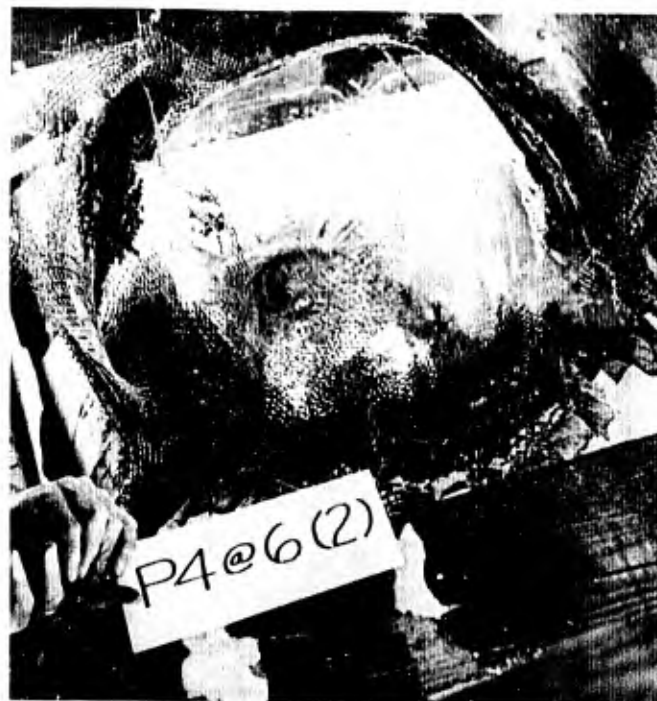
The pier simulator remained undamaged. The top panel damage was mainly punching shear with small flexural yield. The lower panel was destroyed by punching shear and flexure. More energy appeared to be absorbed by the lower panel.

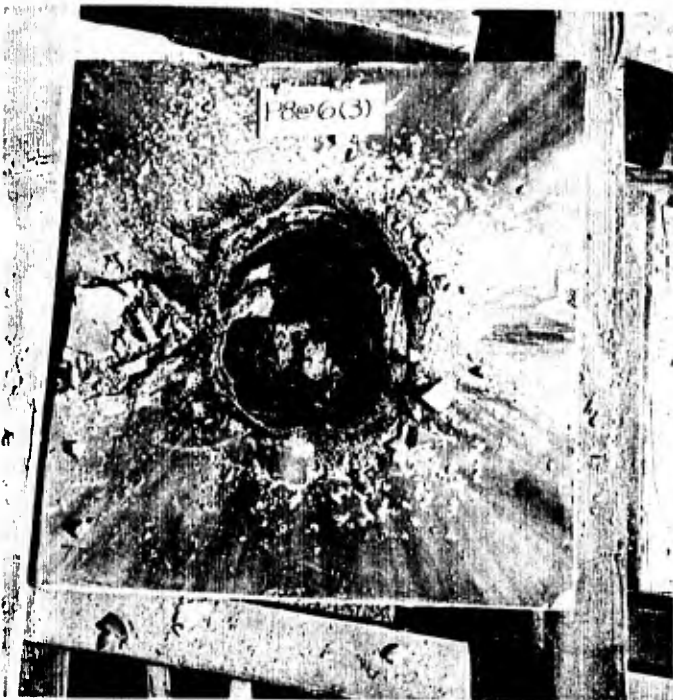
Figure 4-3.401 View Down Through
Three Panels

Three panels, cast July 25, 1968, screed side up, at 6 ft., 5 ft., and 4 ft., respectively, from the pier simulator, were exposed to 8 lbs. of TNT on the top panel, on August 6, 1968. Results are depicted in the following figures:

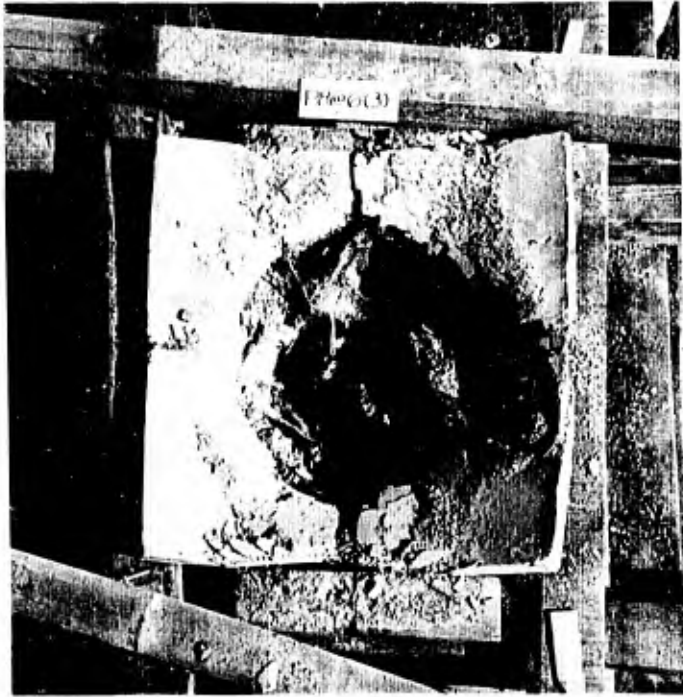
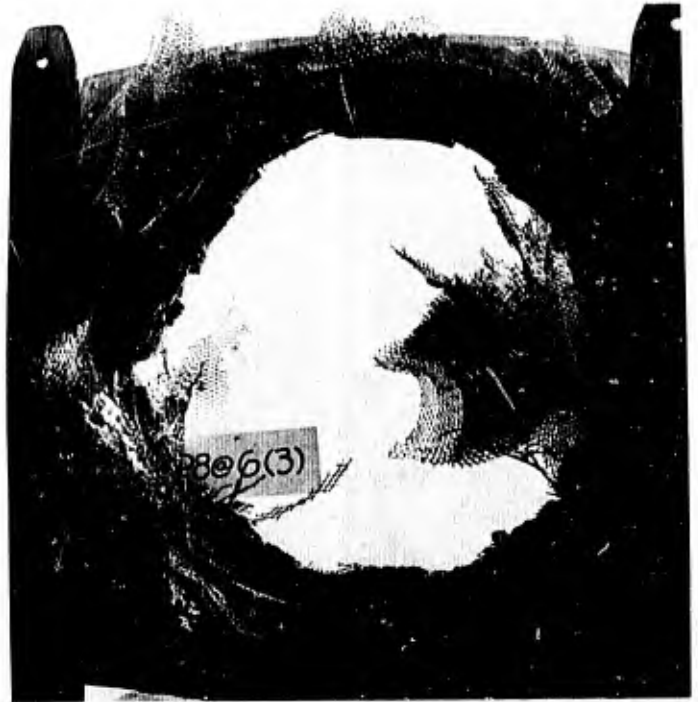
No damage was done to pier simulator. The most energy appeared to be absorbed in the second panel.

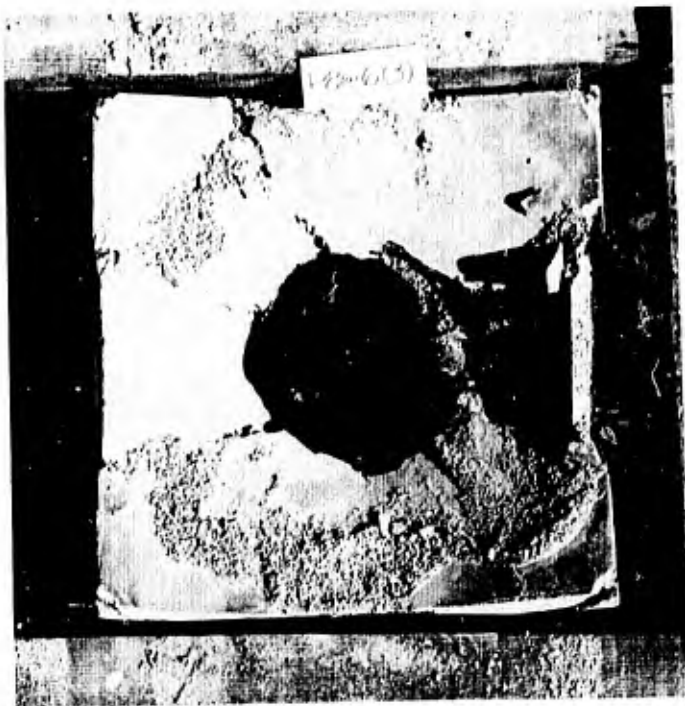
Figure 4-3.406 Upper and Lower Sur-
faces, and 4-3.407 faces, Respectively,
of Third Panel

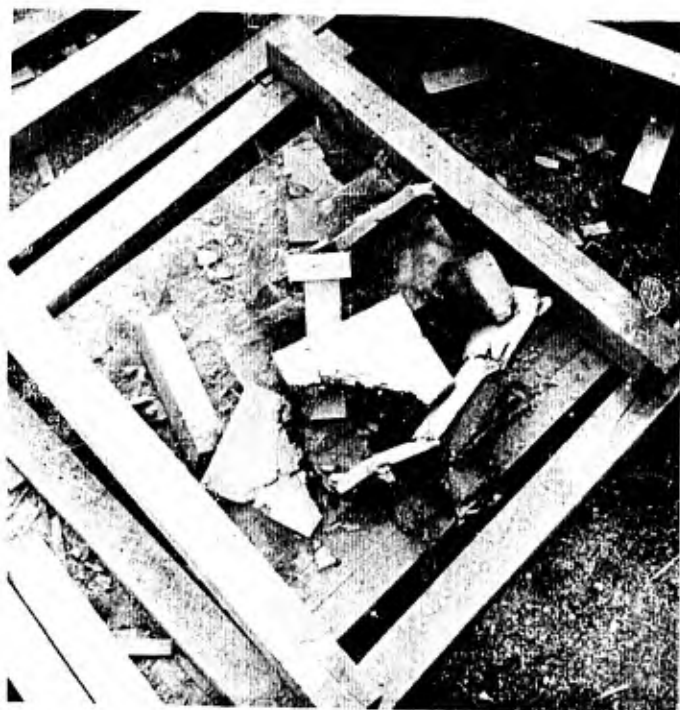
Figure 4-3.502 Criboing Removed to Reveal
Broken Panels

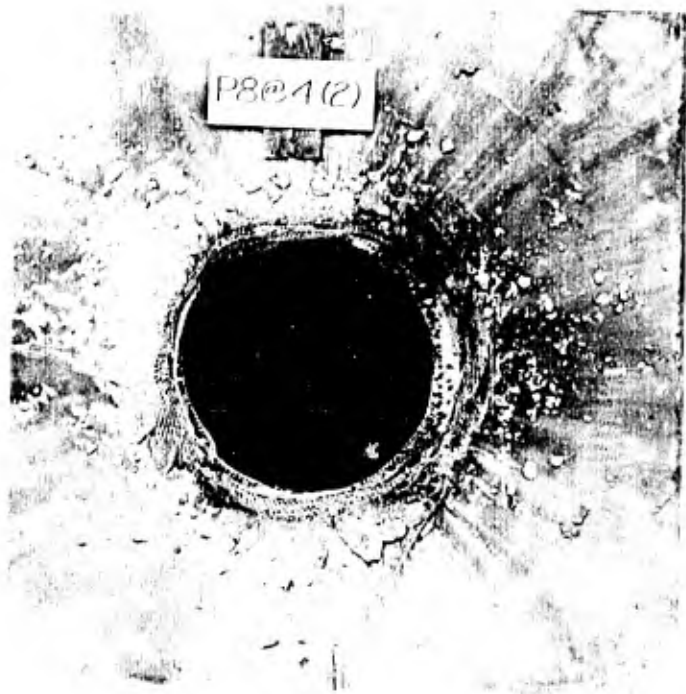
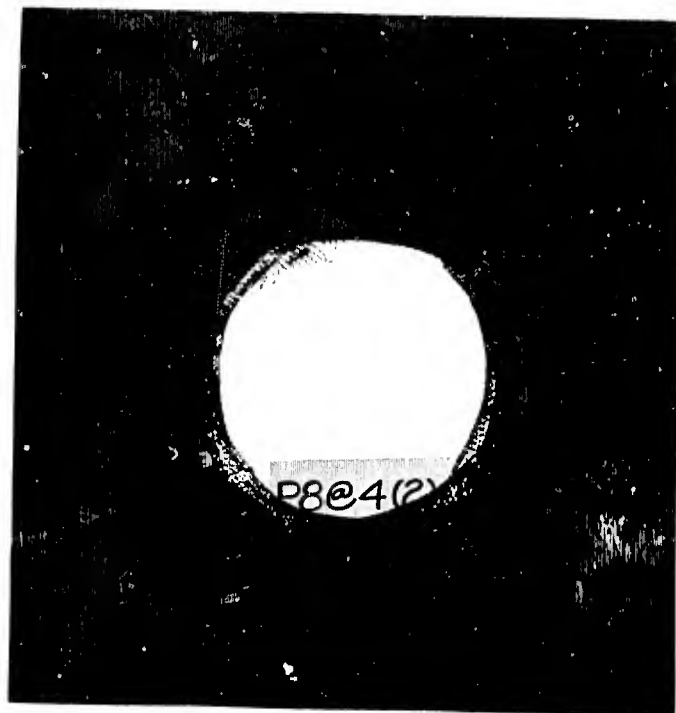
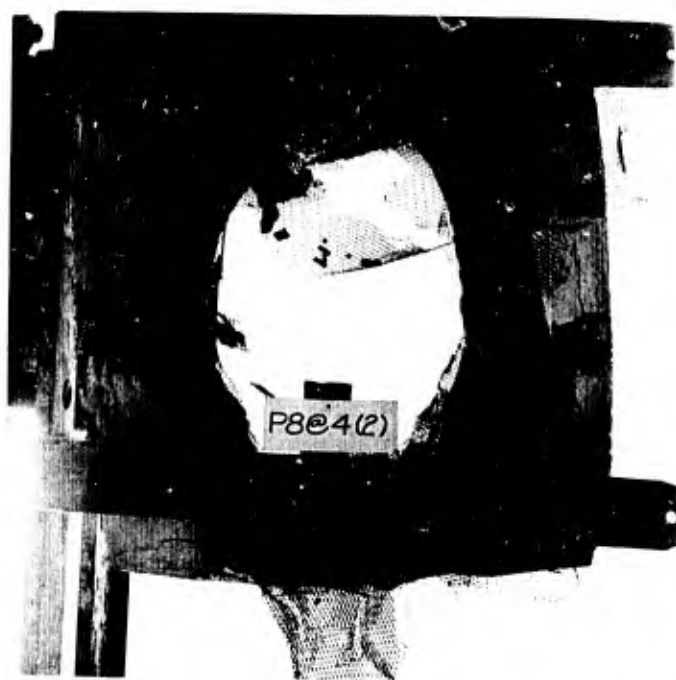
The hole in the top panel is about 16 inches in diameter. Three to four layers of expanded metal are peeled back on the upper surface. The panel is dished downward. Flexural cracking occurred normal to the edges where the distance from the hole to the edge is least. The panel was rotated and displaced somewhat and one fill crib was dislodged, indicating that the panel may have lifted. The mesh on the underside was flared outward more than on the earlier 8 lb. shot with 12 inches between panels.

The second panel revealed closely spaced fracture cracks fanning out radially from the hole in the center. The panel is deeply dished and there is pronounced curvature with no evidence of flexure cracks.

The pier simulator was straight-edged and the residual deflection was found to be $1-1/16$ ", which was the same as measured after the preceding 20 lb. shot.

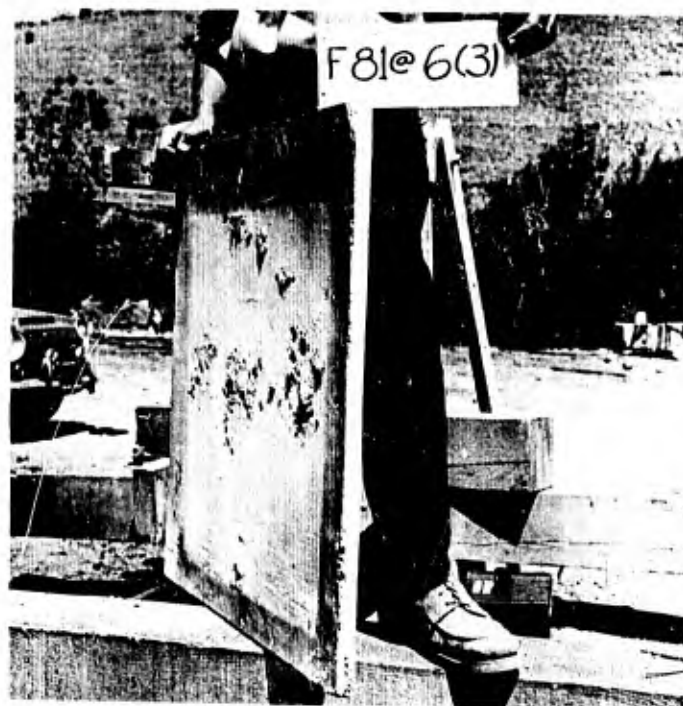
Figure 4-4.209 Front Face of Inter-
mediate Panel

The intermediate panel was not penetrated. Seven small surface spalls barely revealed the outer layer of reinforcement without disturbing it. The rough surfaced mounds are dust adhesions from the front panel. The support was moved backward 3".

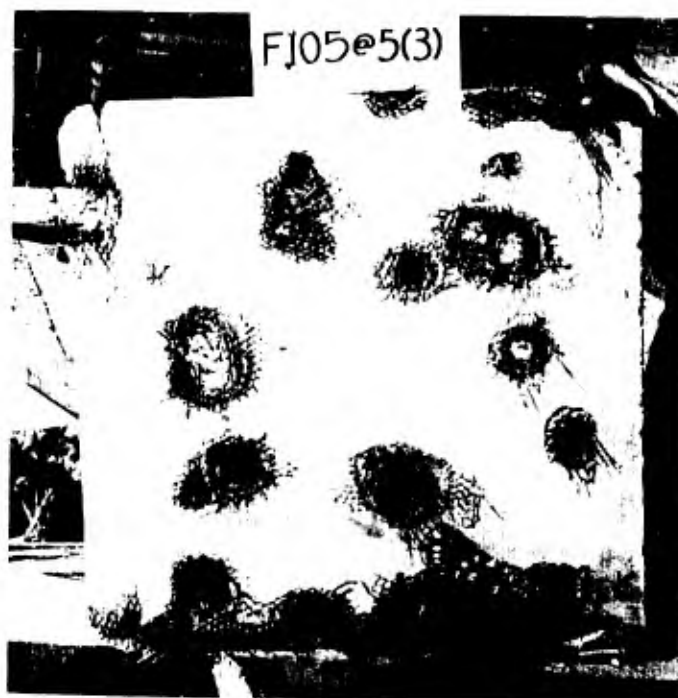
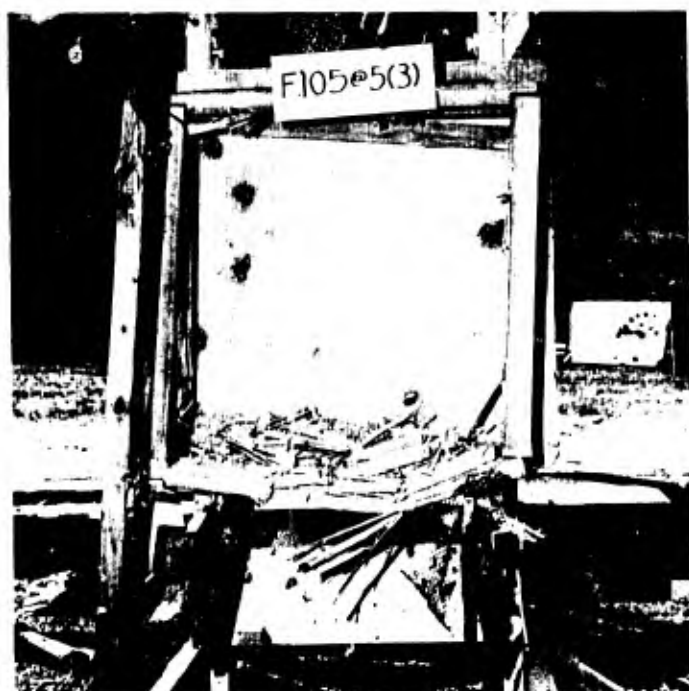
Figure 4-4.306 Rear Face of Rear Panel

Damage to the rear panel was limited to embedment of one large fragment and one deep indentation near the lower edge. Both caused rear face spall without rupture of metal. The support was moved backward 2'-11".
